AESTHETIC RESTORATION OF SEVERELY DECAYED PRIMARY INCISORS WITH FIBRE POSTS AND STRIP CROWNS; A CASE REPORT

Case Report

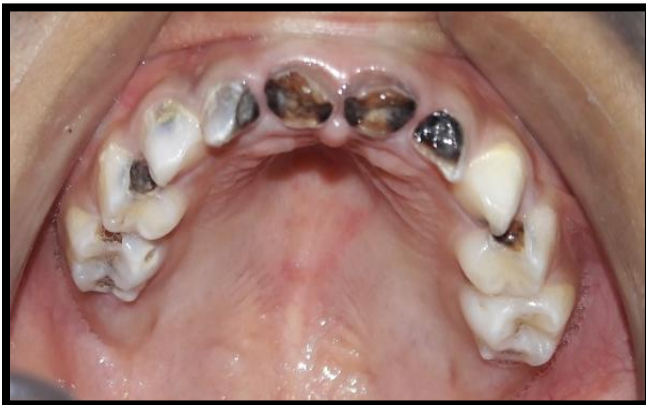
Figure 1: Preoperative intraoral photograph of the patient

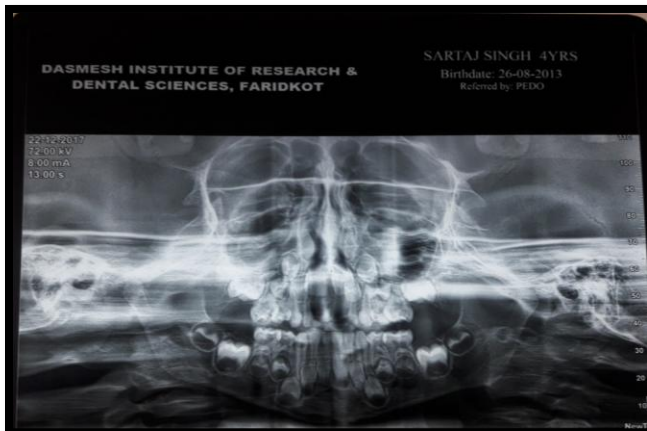
Figure 2: Pre operative Orthopantomogram

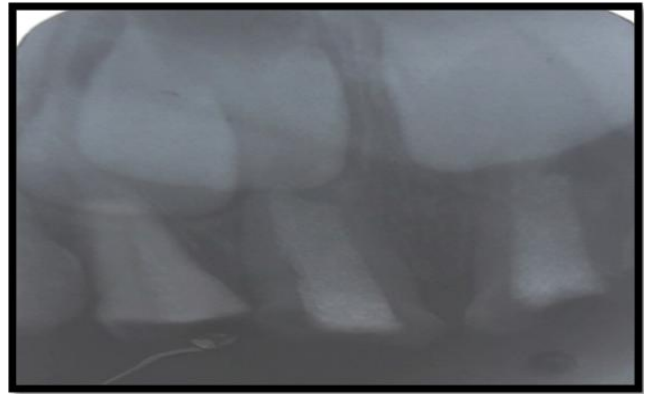
Figure 3: Post obturation radiograph

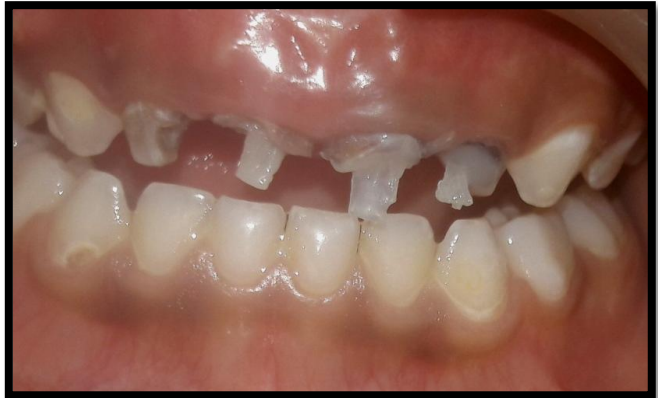
Figure 4: Post placed in the teeth

the root canal walls using applicator with a thin tip and etched for 15 s, washed and dried. The dentin bonding agent was applied using a microbrush and then gently air-dried to evaporate the solvent and cured. The glass fiber post of predetermined thickness and length was placed to a distance of 3 mm into the canal and 2 mm outside the canal along with luting resin and cured for 40 s using a light emitting diode curing unit. For the reconstruction of crown structure composite resin build up was done around the post with the help of celluloid strip crowns which were selected based on the mesiodistal dimension of the tooth (figure 5) The excess composite was removed through small holes punched in the palatal surfaces of the crown. After polymerization for the buccal, palatal, and incisal surfaces, the celluloid crown form was removed by the sharp tip of an explorer. Occlusion was checked interferences in normal and parnormal mandibular movements and finally finished with carbide finishing burs and composite polishing discs was performed. (figure 6) The parents were satisfied with the outcome of treatment. Postoperative orthopantomogram was taken (figure7) After the procedure, the parents and patient were instructed about the care of the restoration and were given proper dietary and oral hygiene instruction. The patient is now on follow-up. [figures 1-7]

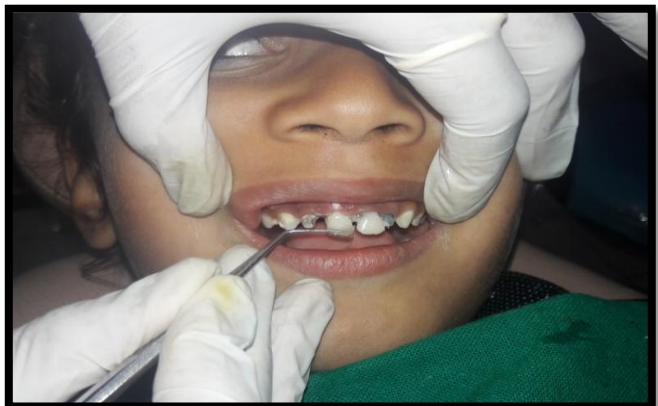
Figure 5: Strip crowns placed

finishing and polishing application. The strip crowns are effective in restoring heavily damaged dental crowns, malformed teeth, hypoplasia and fractured teeth. The restorations offer strength, durability, good aesthetics, as well as greater coverage of the dental remnant and better marginal adaptation.¹⁴

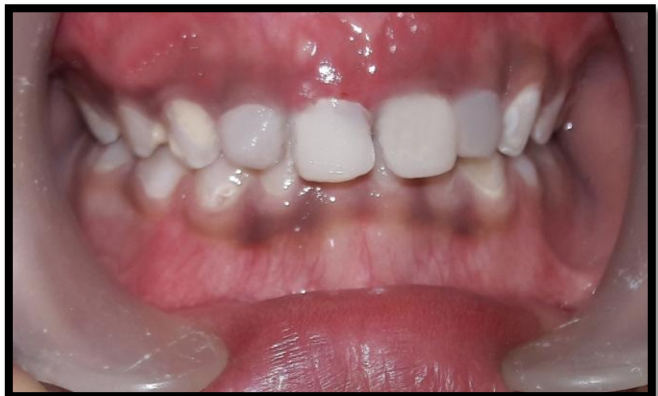
Figure 6: Post operative clinical Photograph

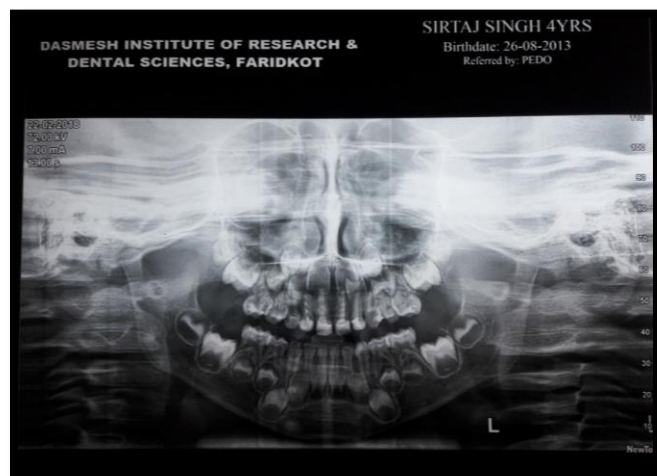
Figure 7: Post operative orthopantomogram
